State of Utah DEPARTMENT OF NATURAL RESOURCES Division of Oil, Gas & Mining

Inspection Rep Minerals Regulator October 26, 20	y Program	Reviewed:	PRRY	
Mine Name: Italian Tan	Permit r	Permit number: S/007/0038		
Operator Name: Quality Building Stone	Inspection Date: October 21, 2010 Time: About 8:30 – 9:30 AM			
I W W				
Inspector(s): Wayne Western Other Participants: Steve Miller				
Mine Status: Inactive	Weather	Weather: Clear, 60's		
Elements of Inspection	Evaluated	Comment	Enforcement	
 Permits, Revisions, Transfer, Bonds, Permit Fees Public Safety (shafts, adits, trash, signs, highwalls) Protection of Drainages / Erosion Control Deleterious Material Roads (maintenance, surfacing, dust control, safety) Concurrent Reclamation Backfilling/Grading (trenches, pits, roads, highwalls, shafts, drill holes) 				
8. Soils9. Revegetation10. Other

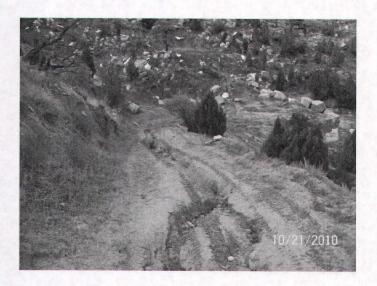
At the request of the land owner, Utah Railway, the Operator received approval to leave a road to the top of the hill. The road and other disturbed areas need to be stabilized to prevent erosion.

Photo 1. The roads need to be graded to prevent ersion, The Division recommends water bars and ditches.
